HISTORIC BLUFF RETREAT AND STABILIZATION AT FLAG HARBOR, CHESAPEAKE BAY, MARYLAND

Inga Clark, Curtis E. Larsen, Michele McRae, U.S. Geological Survey, Reston, VA

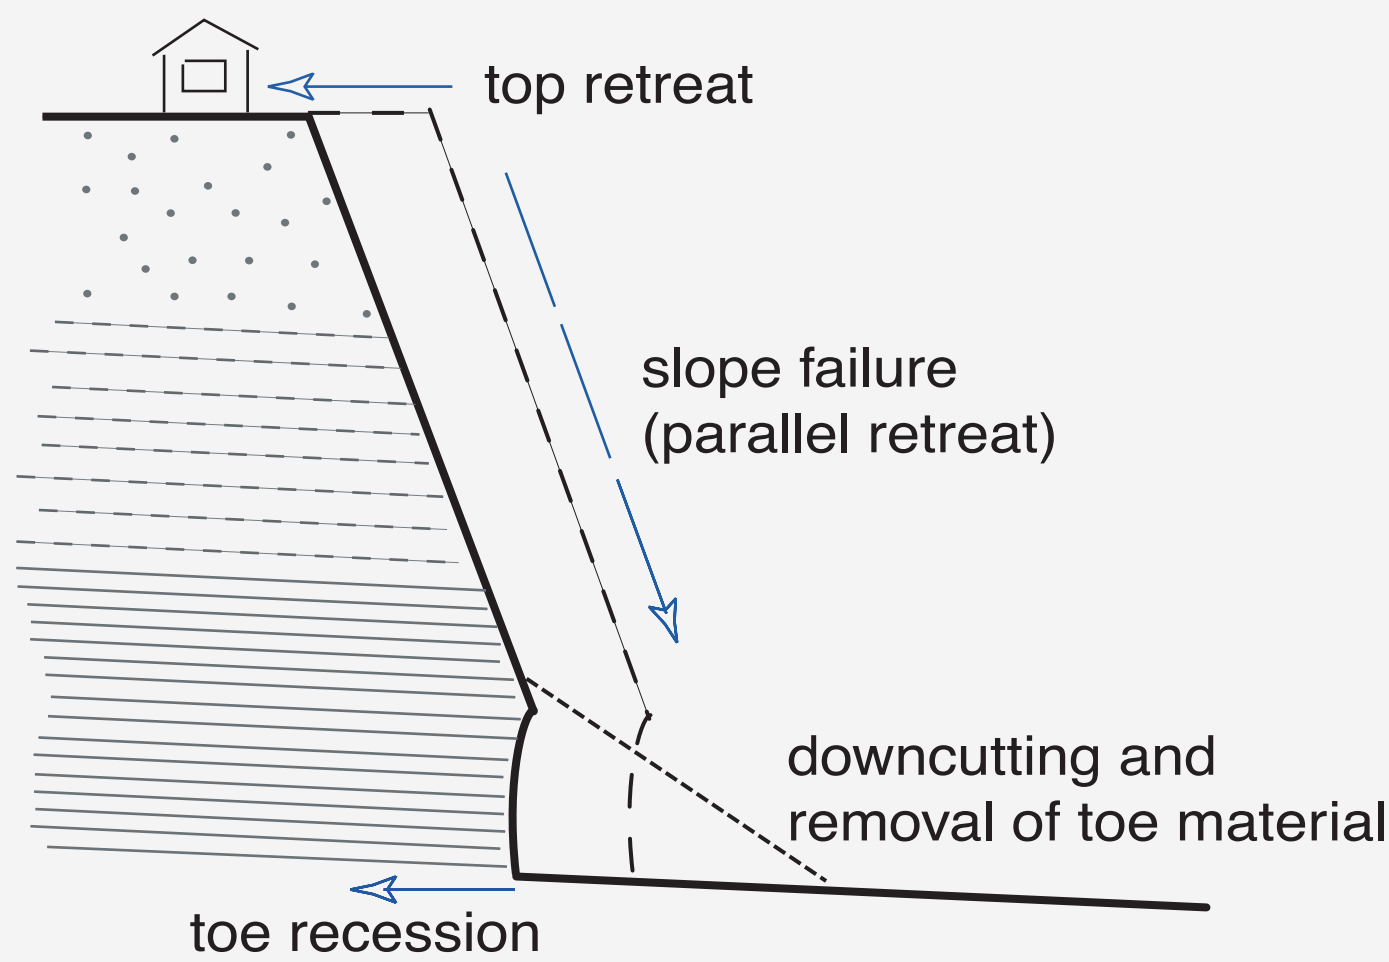
At actively eroding bluffs, wave action erodes intact material at the toe of a bluff. Failure of the slope face and top retreat take place in the form of translational slides and free degradation. Degradation material at the toe of the bluff is removed by waves (pic. 1 - 4)

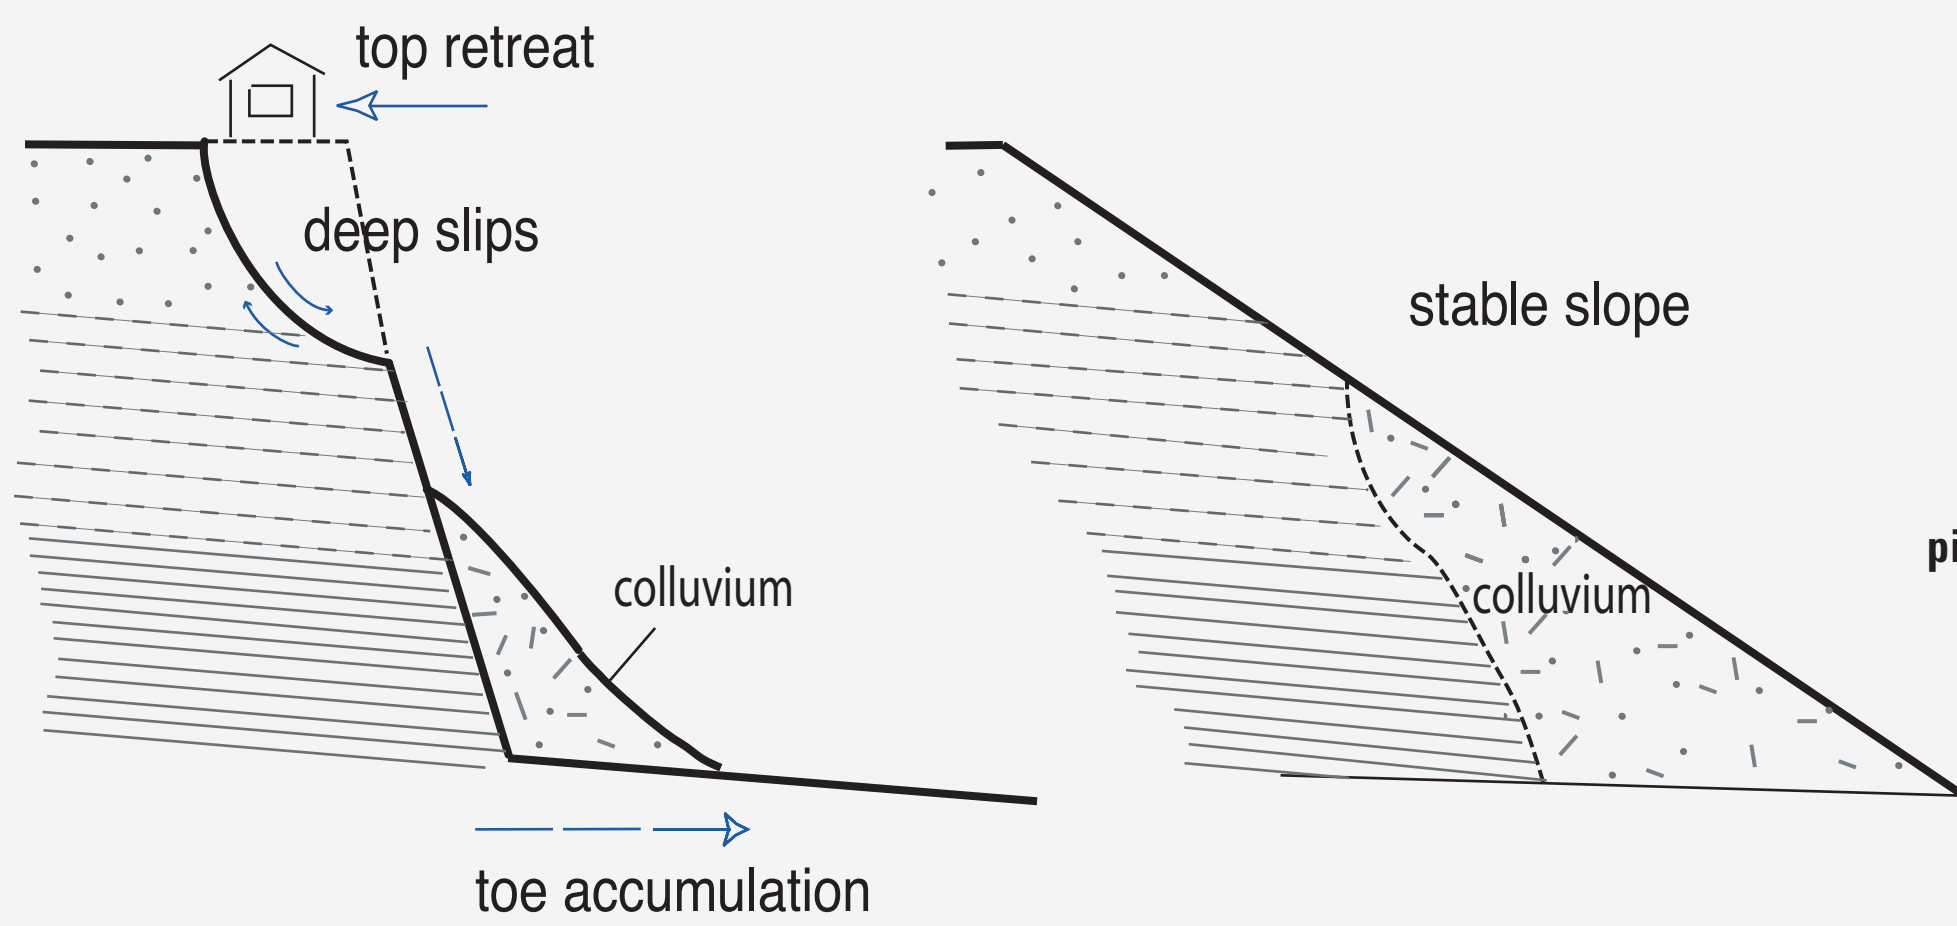
Bluffs protected by a beach progressively attain a uniform stable slope. Rotational slides or slumps propagate from the top of the bluff (pic 5 - 7). Colluvial material is accumulated at the base of the bluff and forms an 'accumulation zone'. Ultimately the slope profile reaches the stable angle equal to the effective angle of shearing resistance of the soil (pic 8).
